8<sup>th</sup> Conference of the International Sports Engineering Association (ISEA)

## Evaluation of pressure insoles during running

Rene El Kati<sup>a\*</sup>, Steph Forrester<sup>a</sup>, Paul Fleming<sup>a</sup>

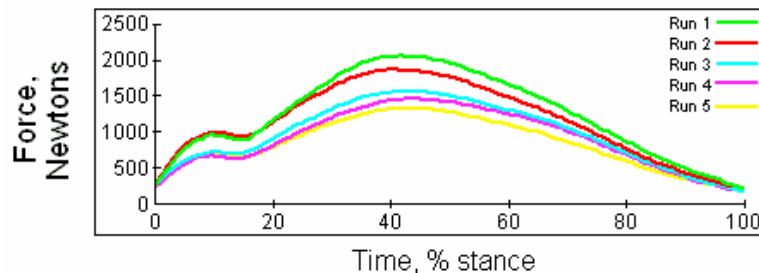
Fig. 1. With each run during the 5 x 1.5 minute test the output of the pressure insole decreased gradually

The force curve of the pressure insoles with the step calibration show that with each run the output decreased substantially, with a 41% drop of the peak force between the first and the last run (Fig. 1). Similar differences were found for specific regions across the foot (Fig 2). Nevertheless the shape of the force curve seemed consistent for all the trials.

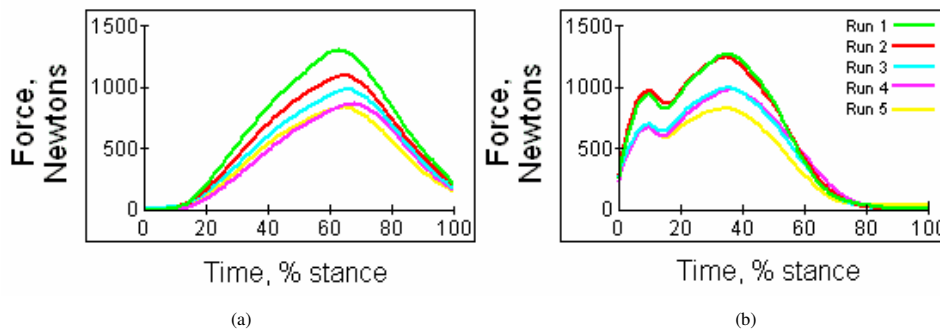
Fig. 2. During the 5 x 1.5 minute runs the output of the insoles decreased both in the forefoot (a) as in the rear foot (b)

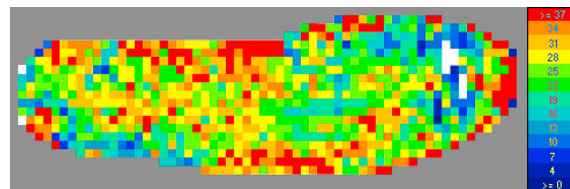
Fig. 3. Putting the insole in the airbladder at a constant pressure after the test showed that the cells did not degrade uniformly, there were also a couple of cells that failed to produce any output.

When the insoles were put in the air bladder after the test it appeared that the forefoot region had degraded more than mid- and rear foot as the output of those cells was less than in other regions under the same pressure (Fig 3). There were also a few cells that failed to produce any output.

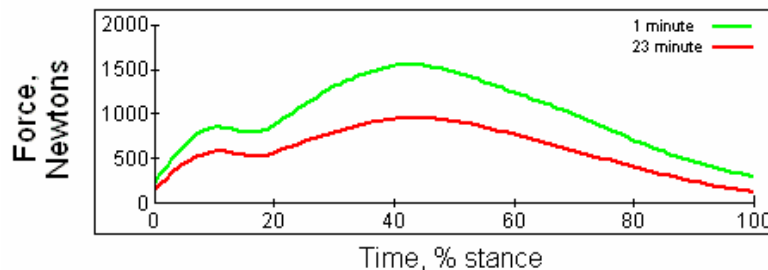
Fig. 4. A comparison of the output at 1 minute and at 23 minutes of the 23 minute shows a clear degradation of the pressure insole

The force curve of the pressure insoles with the step calibration show a similar decrease during the 23 minute run, with a maximal difference in peak force of 47% (Fig 4).

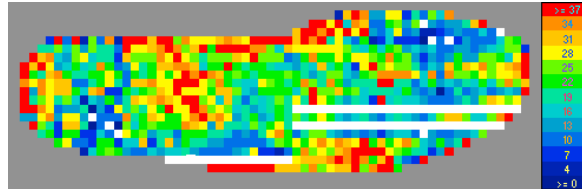
Fig. 6. The white lines in the pressure insole output show the damage that occurred during the 23 minute run

During the 23 minute run the insole sustained a significant amount of damage due to a backwards shift of the insole inside the shoe (Fig 5), resulting in deformation of the rear foot section of the insole and the lower part of the cuff which connects the insole to the data collection device. The airbladder test after the run showed that number of cells did no longer produce any output (Fig 6).

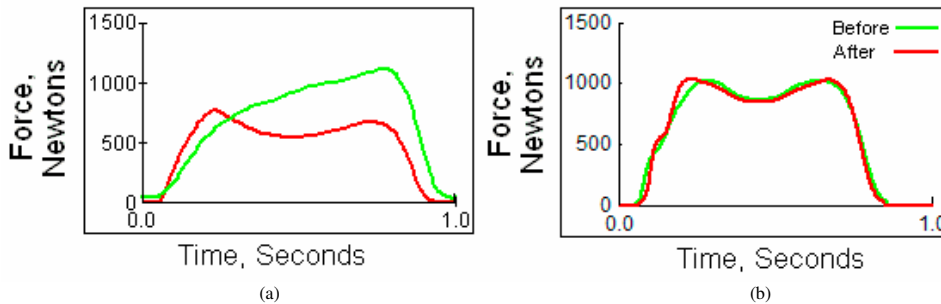
Fig. 7. The output of the walking trials before and after the running tests show the same degradation of the pressure insoles (a), while the output of the force platform remained the same (b).

A comparison between the walks across the force platforms before and after both tests, showed similar decreases in the output of the insoles as during both running tests (Fig 7a). The output of the force platform was similar before and after test (Fig 7b).

Another difference in the output of the pressure insoles was the ground reaction force profile. The walks before the running tests did not have the typical vGRF profile during walking with two peaks [6], whereas the walks after the runs did have this profile (Fig 7a). Though only the two walks after the 5 x 1.5 minute test were used because of the damage of the insole after the 23 minute test, the forces found in the vGRF curve were clearly different to the vGRF measured by the force platform (Table 1).

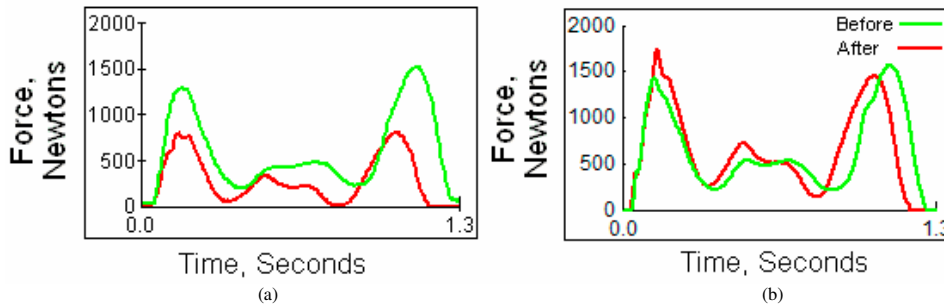
Fig. 8. The output of the jump trials before and after the running tests show the same degradation of the pressure insoles (a), while the output of the force platform remained the same (b)

Comparing the jumps on the force platforms before and after both tests, showed similar decreases in pressure insole output as during both running tests (Fig 8). The output of the force platform stayed in the same range 1436 N – 1742 N before and after each test. In contrast to the results of the walks the force profiles of the jumps are similar before and after the test. However, similar to the results of the walks the forces found were significantly different, though the vGRF of second peak in the first trial was close to that of the force platform, 1527 N vs.1568 N(Table 2).
